Appendix

Site Summaries

Site summaries for each CR4 project site include project descriptions, maps showing the project overview, flood maps from Storlazzi et al. (2019), reef characteristics, primary coastal hazards of concern, and results from the preliminary BCA. General reef condition assessments were determined from the Atlas of the Reefs of West Maui (Minton et al., 2020) and the Assessment of the Resilience of Leeward Maui Reefs (Maynard et al., 2019). It's important to note that in 2015 the Main Hawaiian Islands experienced a mass bleaching event that greatly impacted the reefs on Maui, resulting in an estimated 20-40% loss of coral cover (SSRI, 2017). Still, where appropriate, reef condition also includes the relative reef resilience potential from Maynard et al. (2019). Resilience is the ability of a reef to withstand stressors and maintain a level of ecosystem health that provides key ecological services and functions (Mumby et al., 2007; Nystrom and Folke, 2001). Potential reef resilience is an indication of potential reef restoration success at any particular reef. Reef profiles were approximated using the profile tool in QGIS. However more high-resolution reef profi

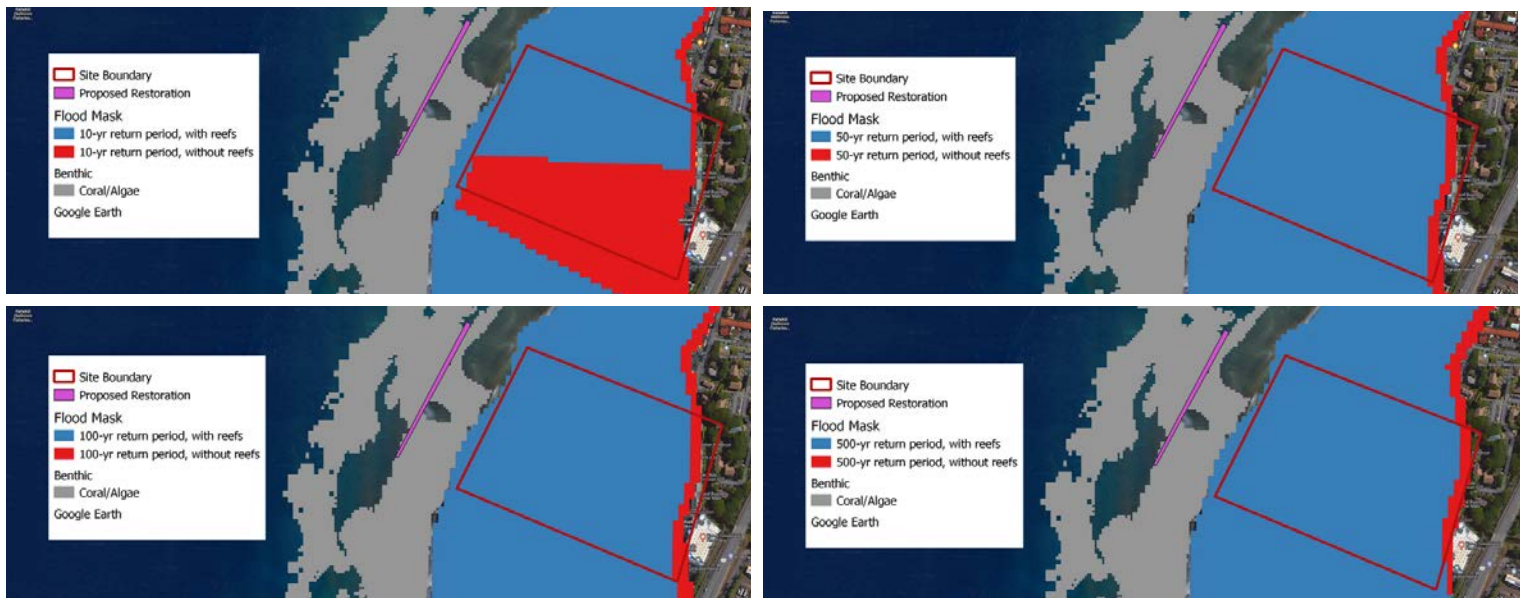
Figure 2A. Maps showing the extent of flooding from multiple storm return periods for the with reefs (blue) and without reefs (red) scenarios at the Ka'anapali Beach Club site.

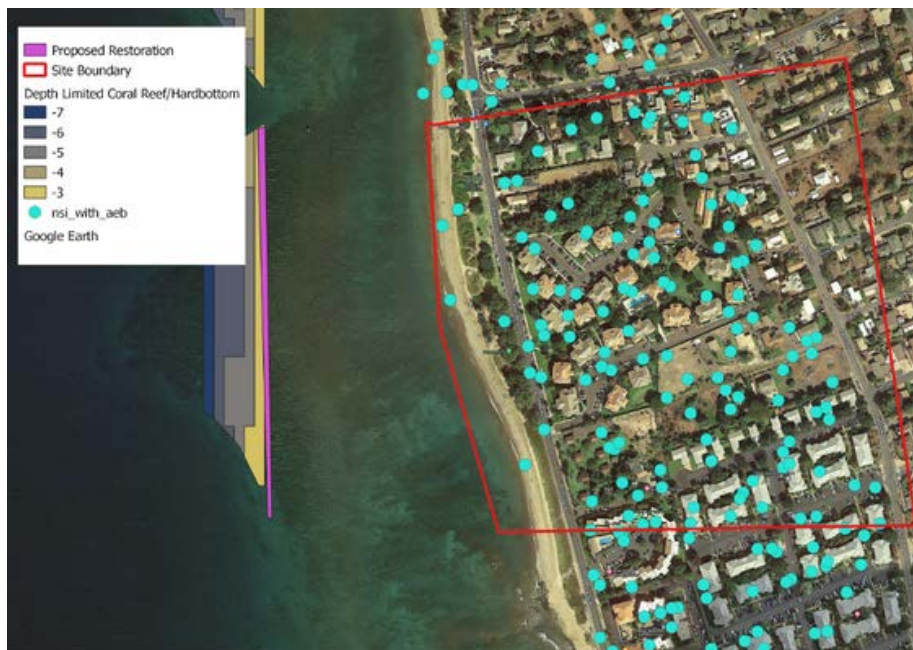
Figure 1B. Map showing the North Kihei CR4 project site. The area predicted to receive the most risk reduction benefits from the restoration project is outlined in red. The individual structure annual expected benefit provided by the addition of 1m in reef height is summarized by the teal dots. The isolated area considered feasible for restoration based on depth from 2 m to 7 m and existing coral reef or hardbottom benthos is represented in shades of yellow to blue. The proposed restoration project site is represented in purple.

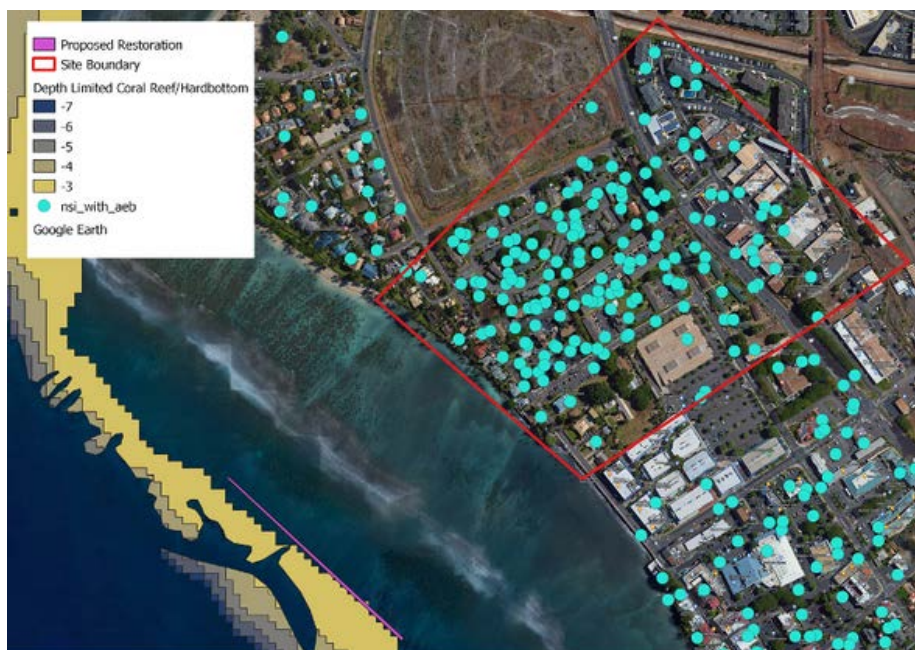
Figure 1C. Map showing the Lahaina CR4 project site. The area predicted to receive the most risk reduction benefits from the restoration project is outlined in red. The individual structure annual expected benefit provided by the addition of 1m in reef height is summarized by the teal dots. The isolated area considered feasible for restoration based on depth from 2 m to 7 m and existing coral reef or hardbottom benthos is represented in shades of yellow to blue. The proposed restoration project site is represented in purple.

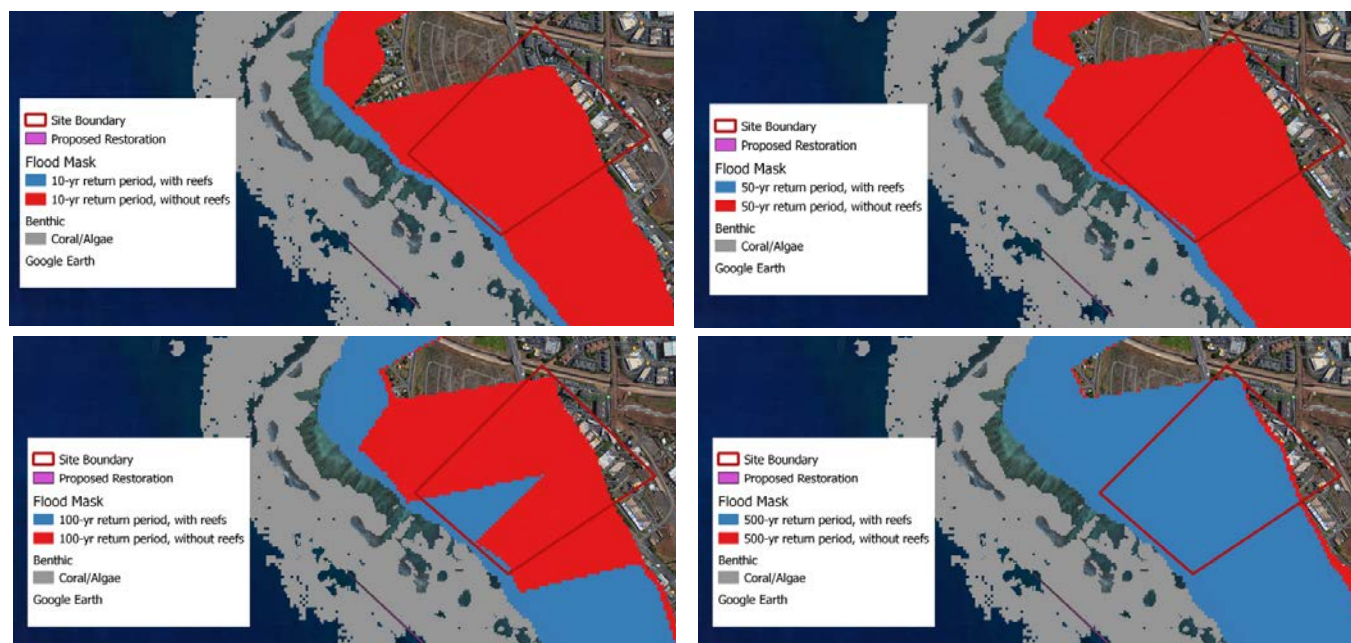
Figure 2C. Maps showing the extent of flooding from multiple storm return periods for the with reefs (blue) and without reefs (red) scenarios at the Lahaina site.

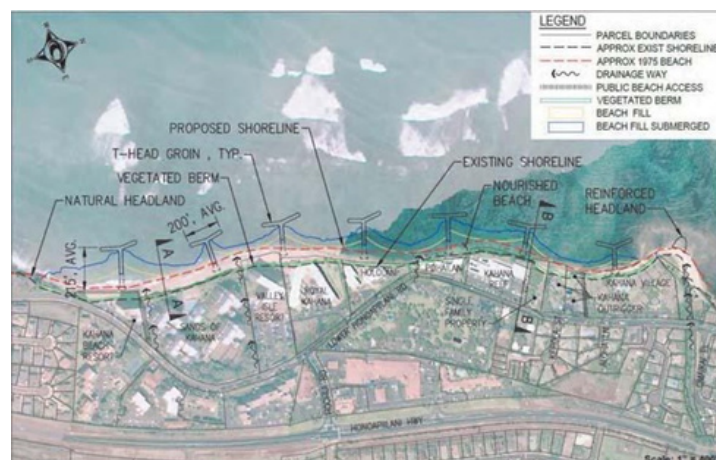
Figure 1D. A rendering of the proposed T-groin and beach restoration project to enhance and restore the beach and reduce erosion in the Kahana project area.

The Kahana site extends from Kahana Village Vacation Rentals on the north end to Kahana Villas on the southern end. This site was selected because of multi-stakeholder interest in investigating the potential of a reef restoration project to deliver risk reduction benefits to the Kahana shoreline region in West Maui. This shoreline area has a history of significant erosion and flooding events, with most properties along the shore resorting to sandbags or grandfathered-in seawalls to protect their assets. While this is the largest proposed restoration project and associated land area to receive risk reduction benefits, it is crucial to consider this coastline because it contains the entire littoral cell of this region, and alternative proposed projects to mitigate erosion extend along this exact length. For example, the primary project proposed to retain and restore the sandy beach and reduce erosion in this area is to install a series of T-groins designed to protect the adjacent properties and keep the sand in place along the shoreline (see Fig. 1D).

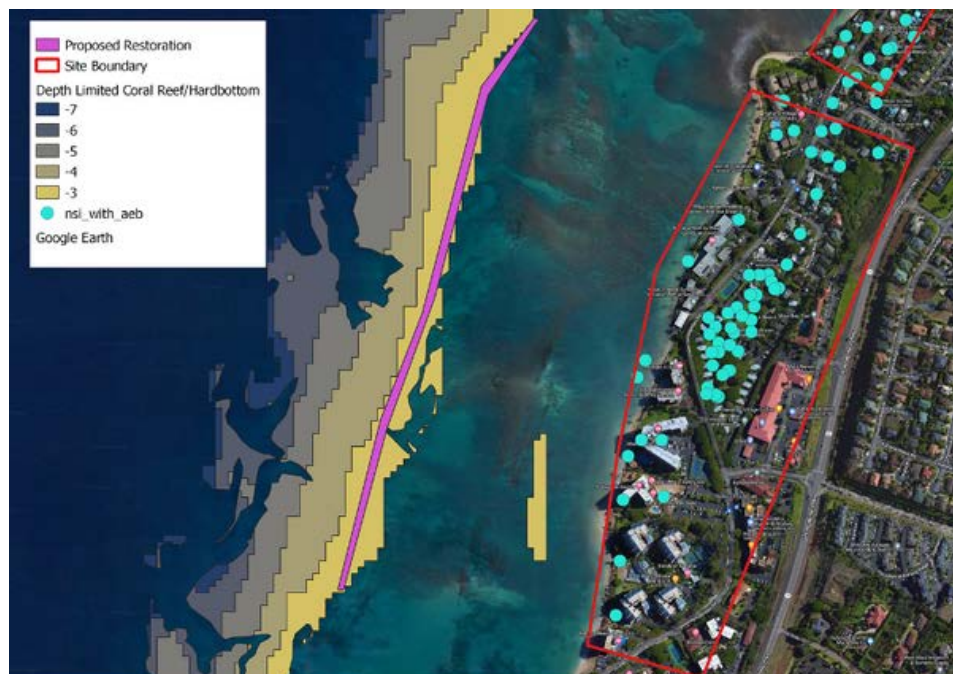
Figure 2D. Map showing the Kahana CR4 project site. The area predicted to receive the most risk reduction benefits from the restoration project is outlined in red. The individual structure annual expected benefit provided by the addition of 1m in reef height is summarized by the teal dots. The isolated area considered feasible for restoration based on depth from 2 m to 7 m and existing coral reef or hardbottom benthos is represented in shades of yellow to blue. The proposed restoration project site is represented in purple.

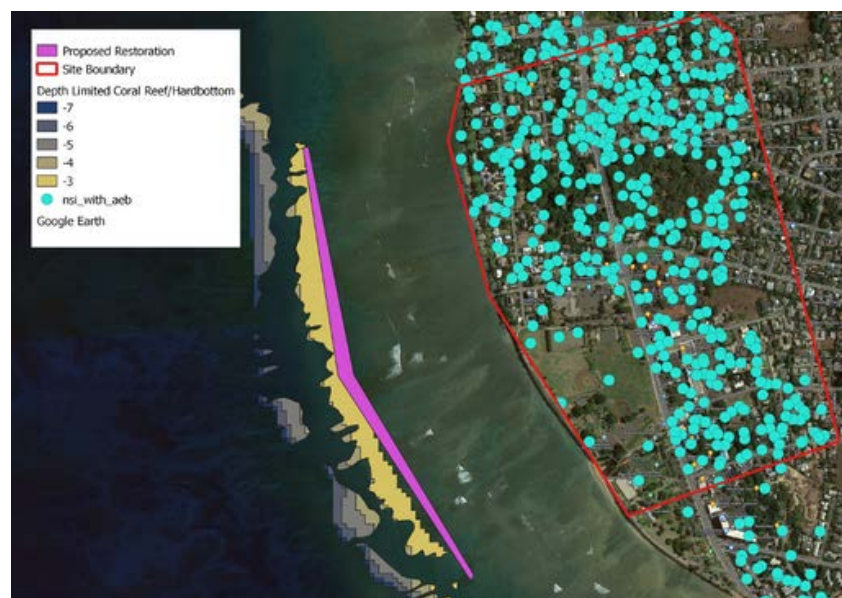
Figure 1E. Map showing the South Kihei CR4 project site. The area predicted to receive the most risk reduction benefits from the restoration project is outlined in red. The individual structure annual expected benefit provided by the addition of 1m in reef height is summarized by the teal dots. The isolated area considered feasible for restoration based on depth from 2 m to 7 m and existing coral reef or hardbottom benthos is represented in shades of yellow to blue. The proposed restoration project site is represented in purple.

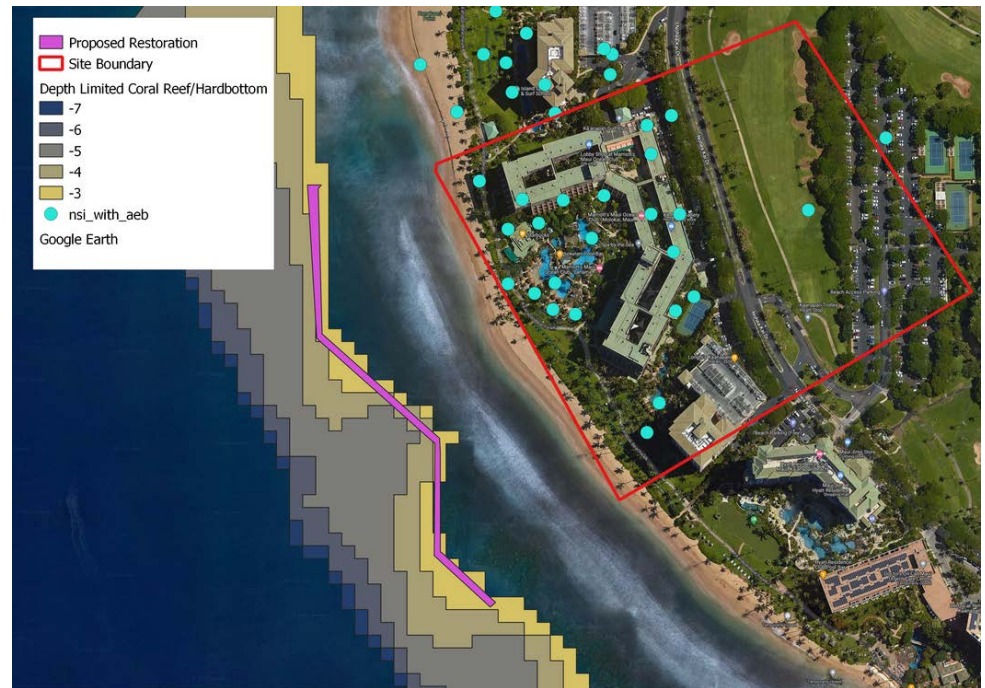
Figure 1G. Map showing the Ka'anapali Marriott CR4 project site. The area predicted to receive the most risk reduction benefits from the restoration project is outlined in red. The individual structure annual expected benefit provided by the addition of 1m in reef height is summarized by the teal dots. The isolated area considered feasible for restoration based on depth from 2 m to 7 m and existing coral reef or hardbottom benthos is represented in shades of yellow to blue. The proposed restoration project site is represented in purple.

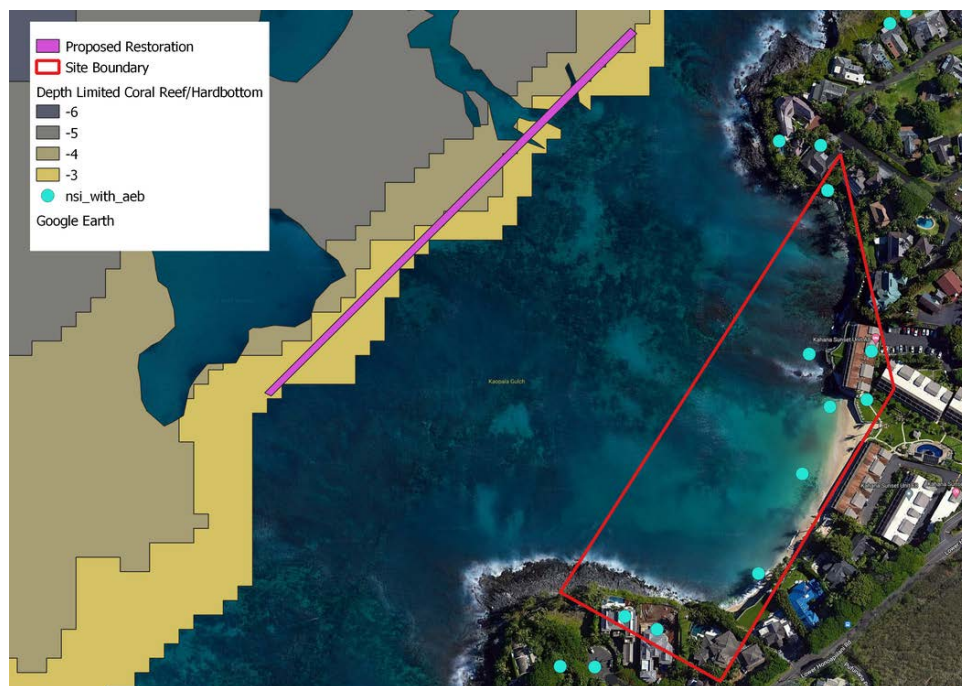
Figure 1H. Map showing the Kahana Sunset CR4 project site. The area predicted to receive the most risk reduction benefits from the restoration project is outlined in red. The individual structure annual expected benefit provided by the addition of 1m in reef height is summarized by the teal dots. The isolated area considered feasible for restoration based on depth from 2 m to 7 m and existing coral reef or hardbottom benthos is represented in shades of yellow to blue. The proposed restoration project site is represented in purple.

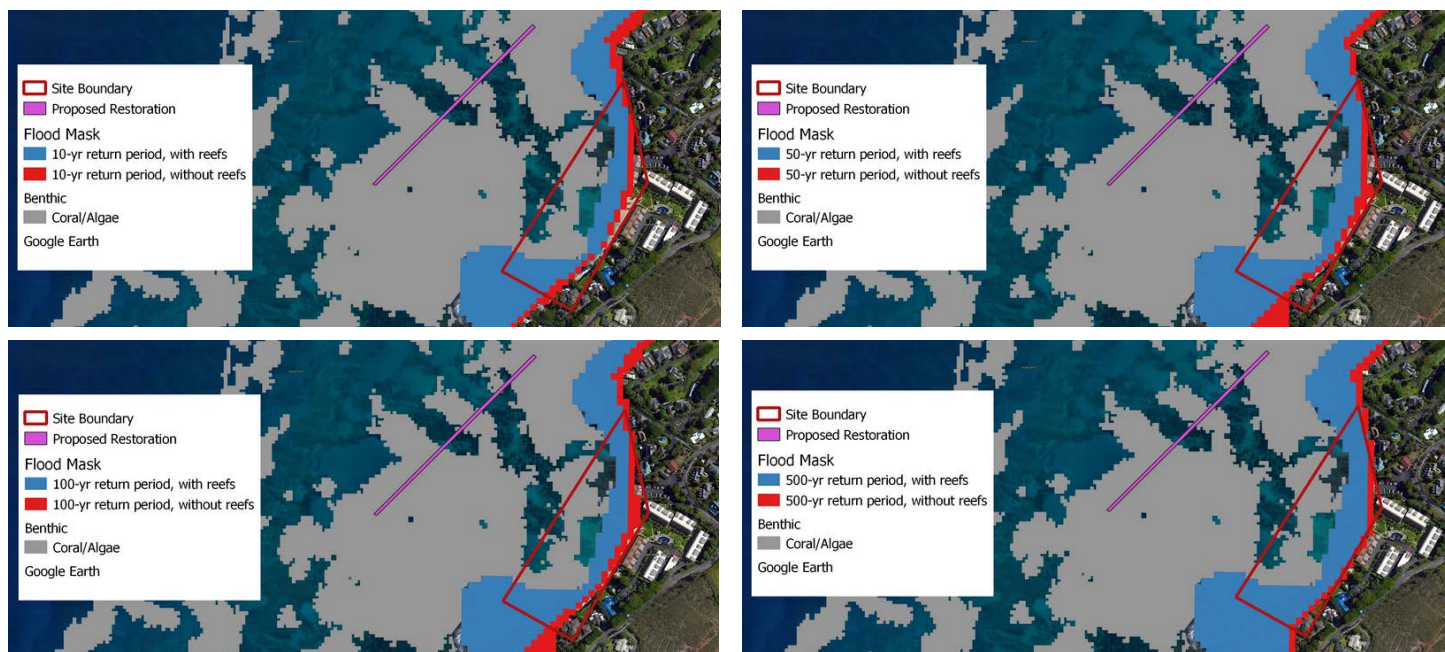
Figure 2H. Maps showing the extent of flooding from multiple storm return periods for the with reefs (blue) and without reefs (red) scenarios at the Kahana Sunset site.

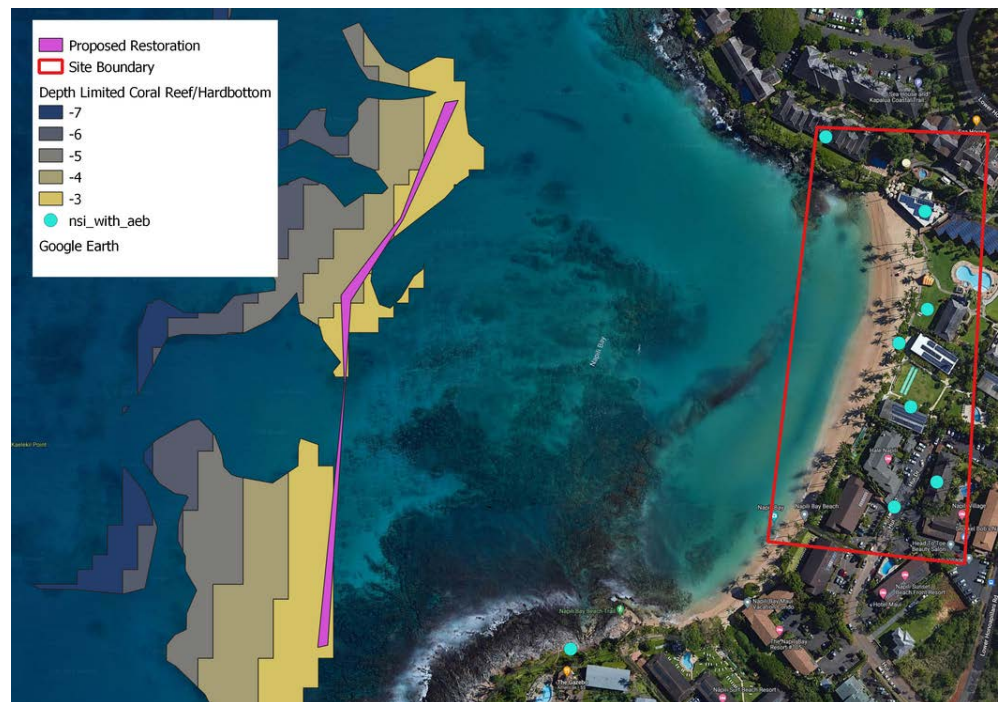
Figure 1I.. Map showing the Napili Bay CR4 project site. The area predicted to receive the most risk reduction benefits from the restoration project is outlined in red. The individual structure annual expected benefit provided by the addition of 1m in reef height is summarized by the teal dots. The isolated area considered feasible for restoration based on depth from 2 m to 7 m and existing coral reef or hardbottom benthos is represented in shades of yellow to blue. The proposed restoration project site is represented in purple.

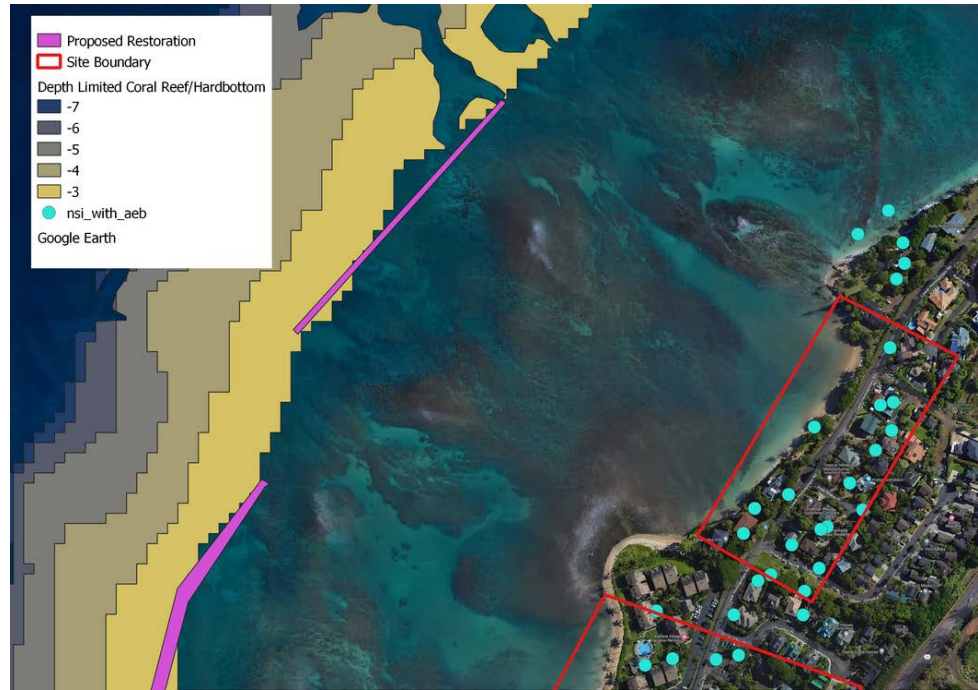
Figure 1J. Map showing the Kahanaiki Gulch CR4 project site. The area predicted to receive the most risk reduction benefits from the restoration project is outlined in red. The individual structure annual expected benefit provided by the addition of 1m in reef height is summarized by the teal dots. The isolated area considered feasible for restoration based on depth from 2 m to 7 m and existing coral reef or hardbottom benthos is represented in shades of yellow to blue. The proposed restoration project site is represented in purple.

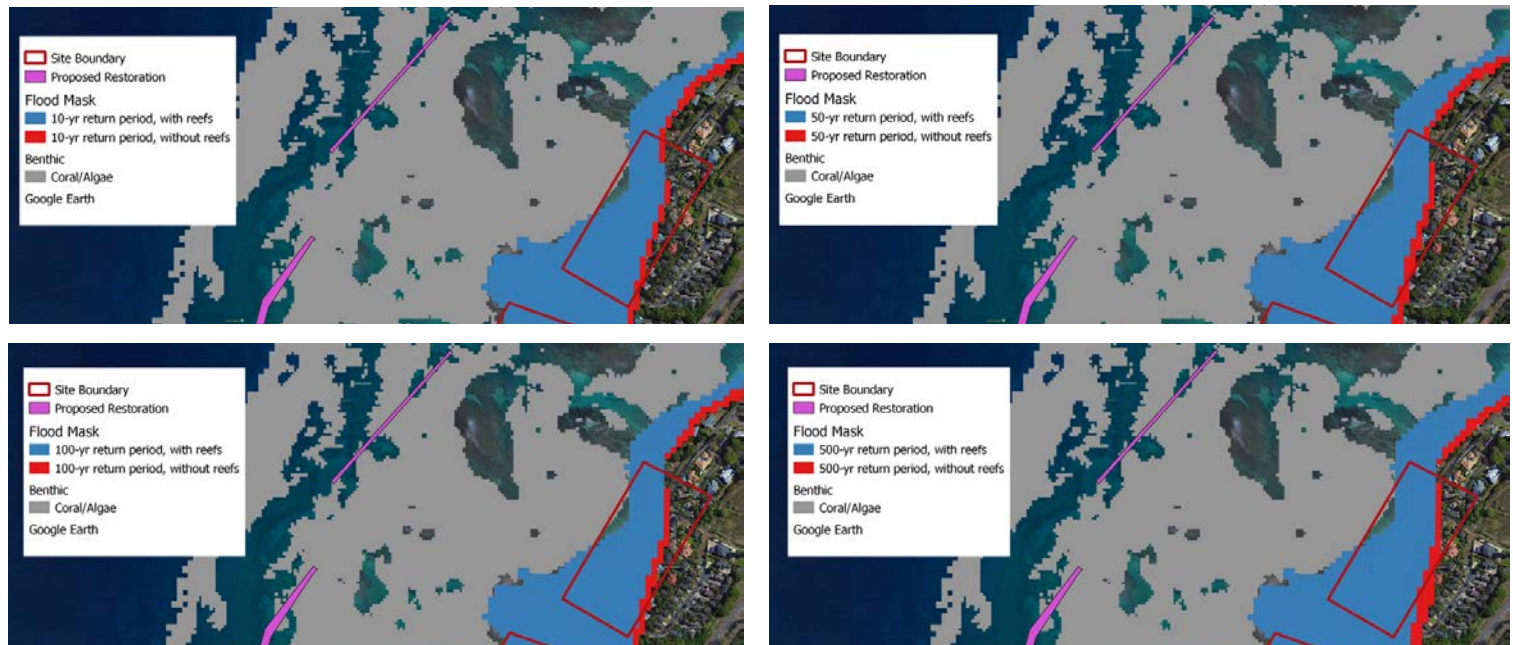
Figure 2J. Maps showing the extent of flooding from multiple storm return periods for the with reefs (blue) and without reefs (red) scenarios at the Kahanaiki Gulch site.

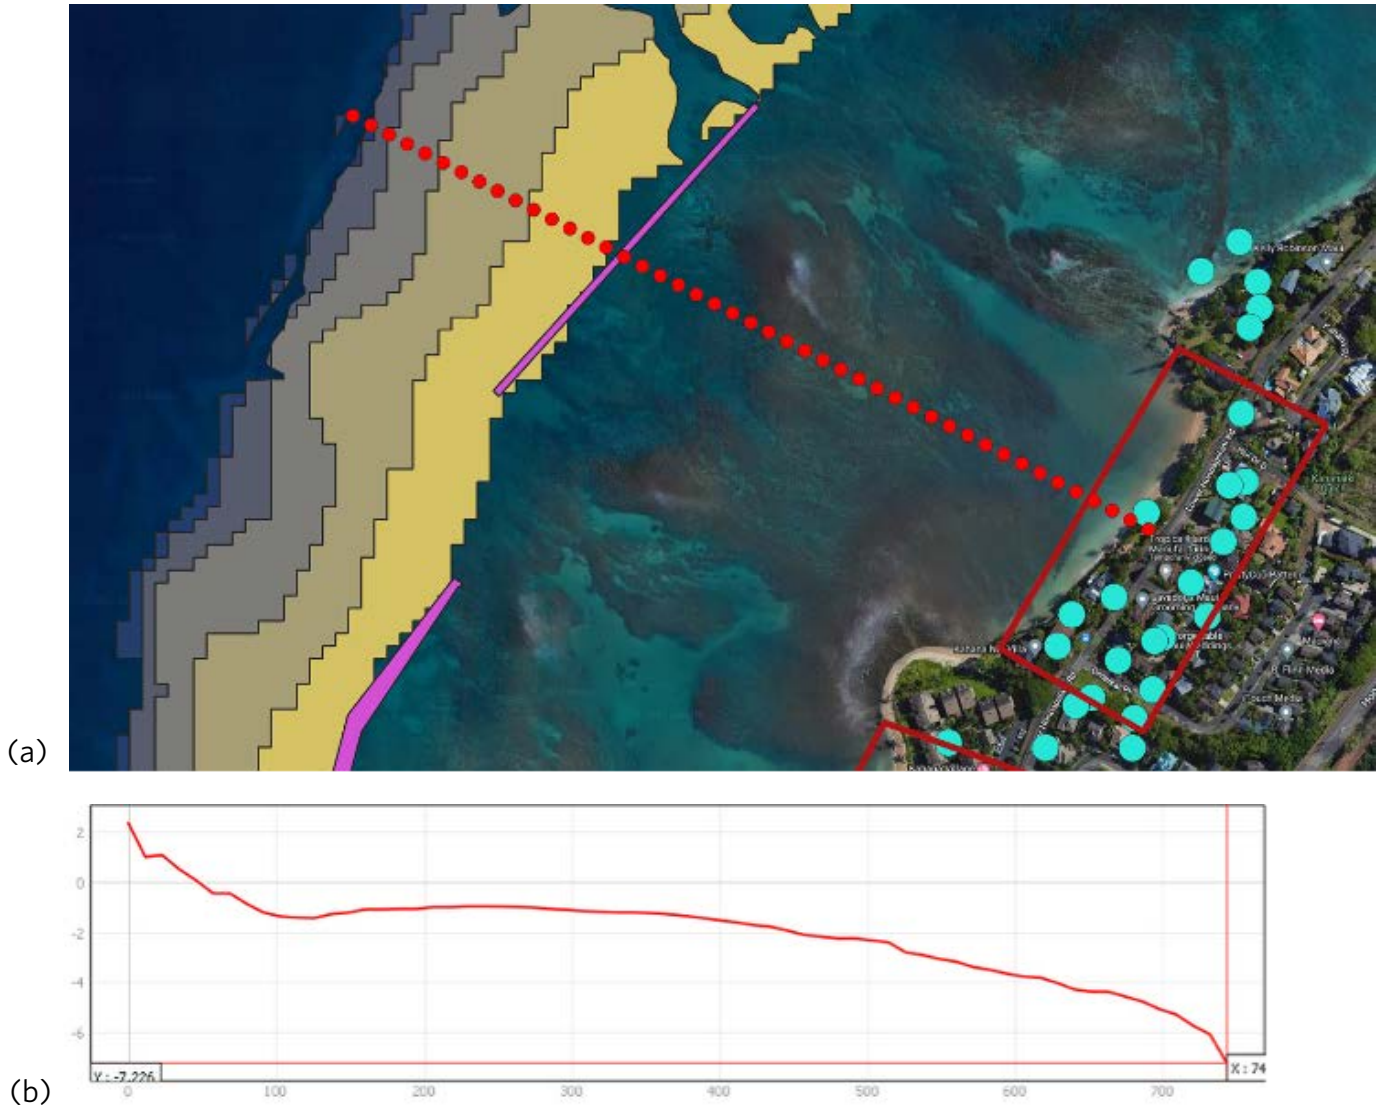
Figure 3J. (a) A screenshot of the approximate cross-shore transect examined using the profile tool in QGIS to evaluate the general reef profile within the 2-7 m depth range. (b) A view of the cross-shore reef profile from the beach out to the end of the 7m depth range. The y-axis is approximate depth in meters. The reef profile between 2-7 m depth starts at the 500 value on the x-axis.

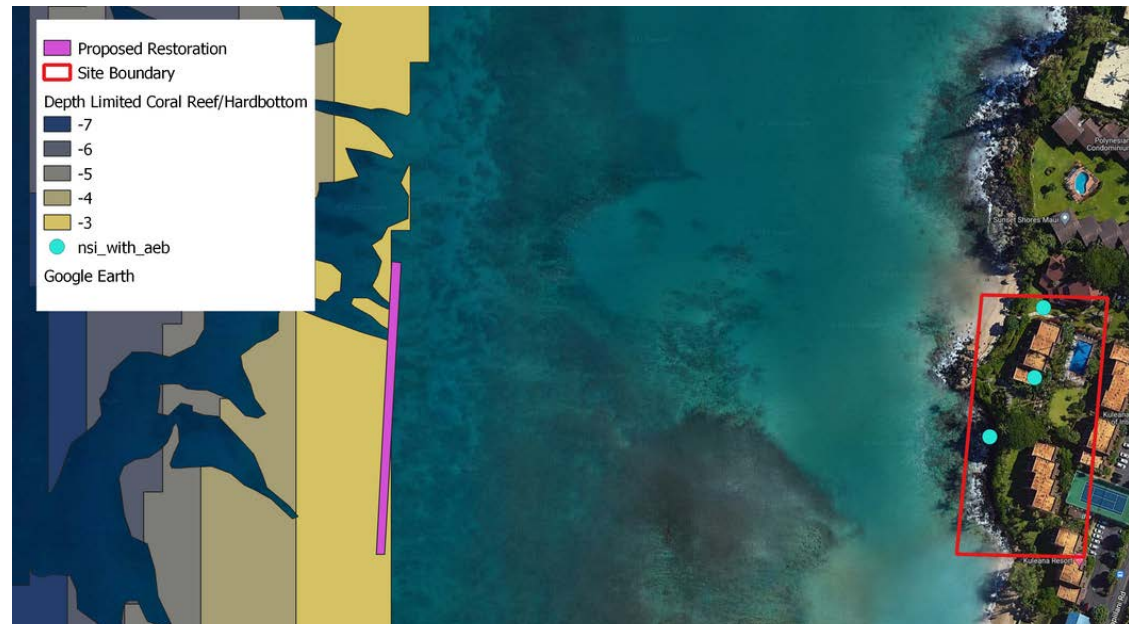
Figure 1K. Map showing the Kuleana Resort CR4 project site. The area predicted to receive the most risk reduction benefits from the restoration project is outlined in red. The individual structure annual expected benefit provided by the addition of 1m in reef height is summarized by the teal dots. The isolated area considered feasible for restoration based on depth from 2 m to 7 m and existing coral reef or hardbottom benthos is represented in shades of yellow to blue. The proposed restoration project site is represented in purple.

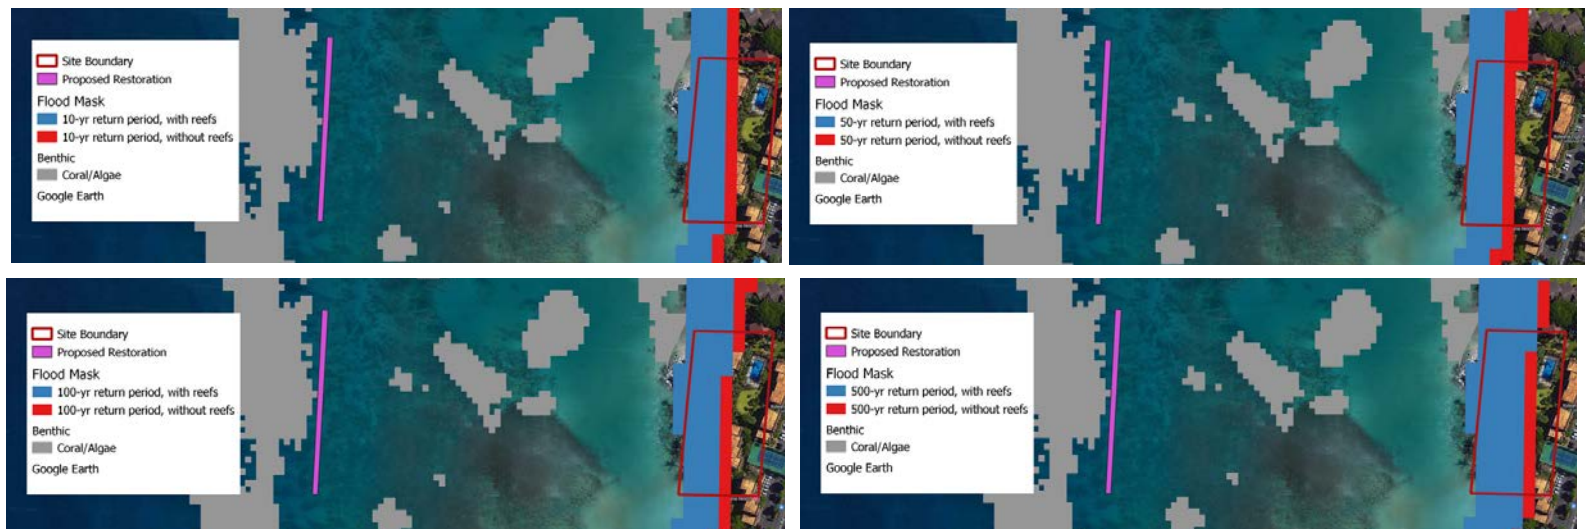
Figure 2K. Maps showing the extent of flooding from multiple storm return periods for the with reefs (blue) and without reefs (red) scenarios at the Kuleana Resort site.

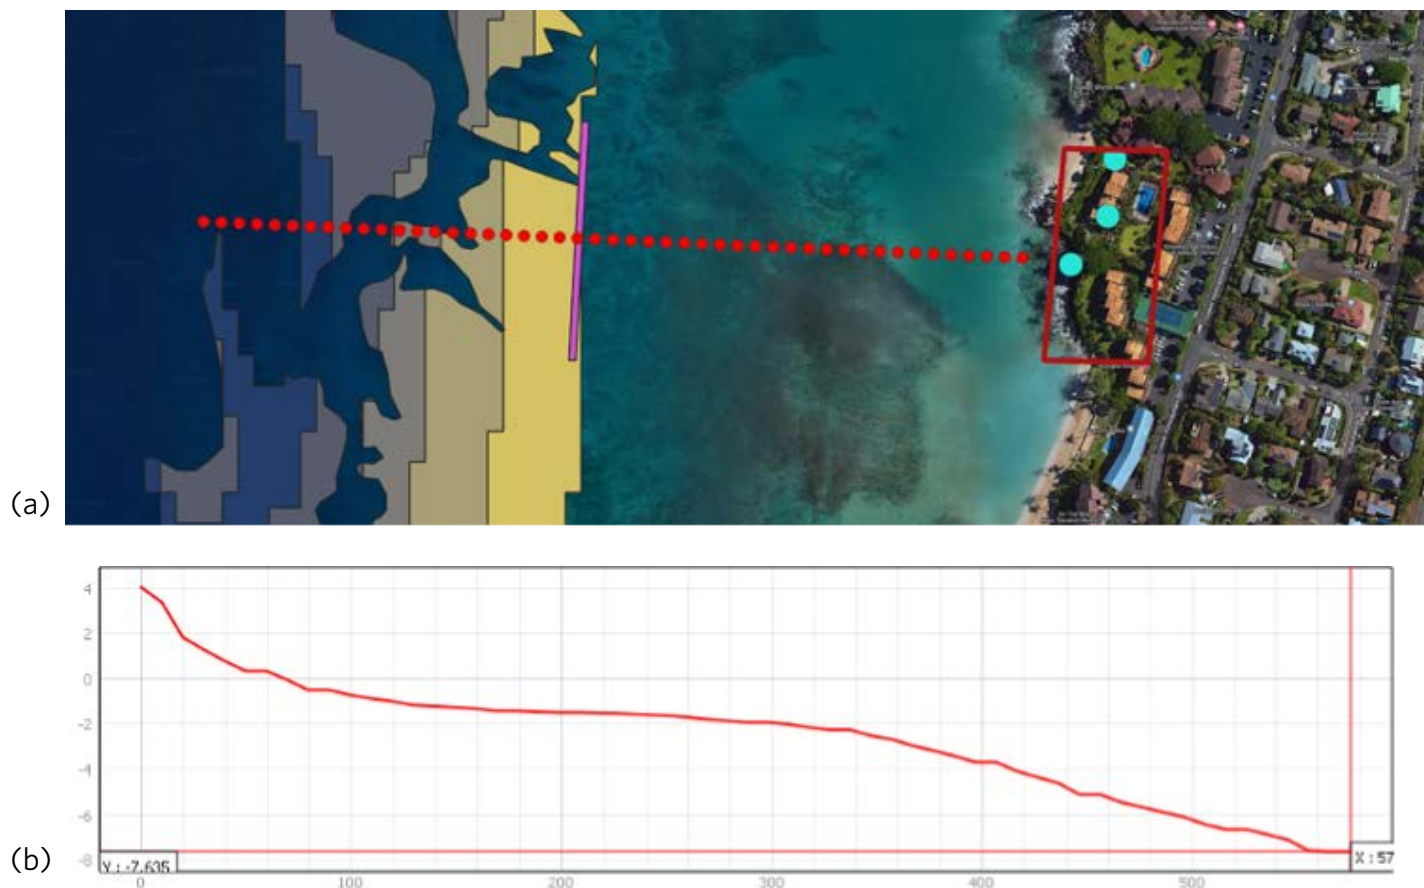
Figure 3K. (a) A screenshot of the approximate cross-shore transect examined using the profile tool in QGIS to evaluate the general reef profile within the 2-7 m depth range. (b) A view of the cross-shore reef profile from the beach out to the end of the 7m depth range. The y-axis is approximate depth in meters. The reef profile between 2-7 m depth starts at the 350 value on the x-axis.

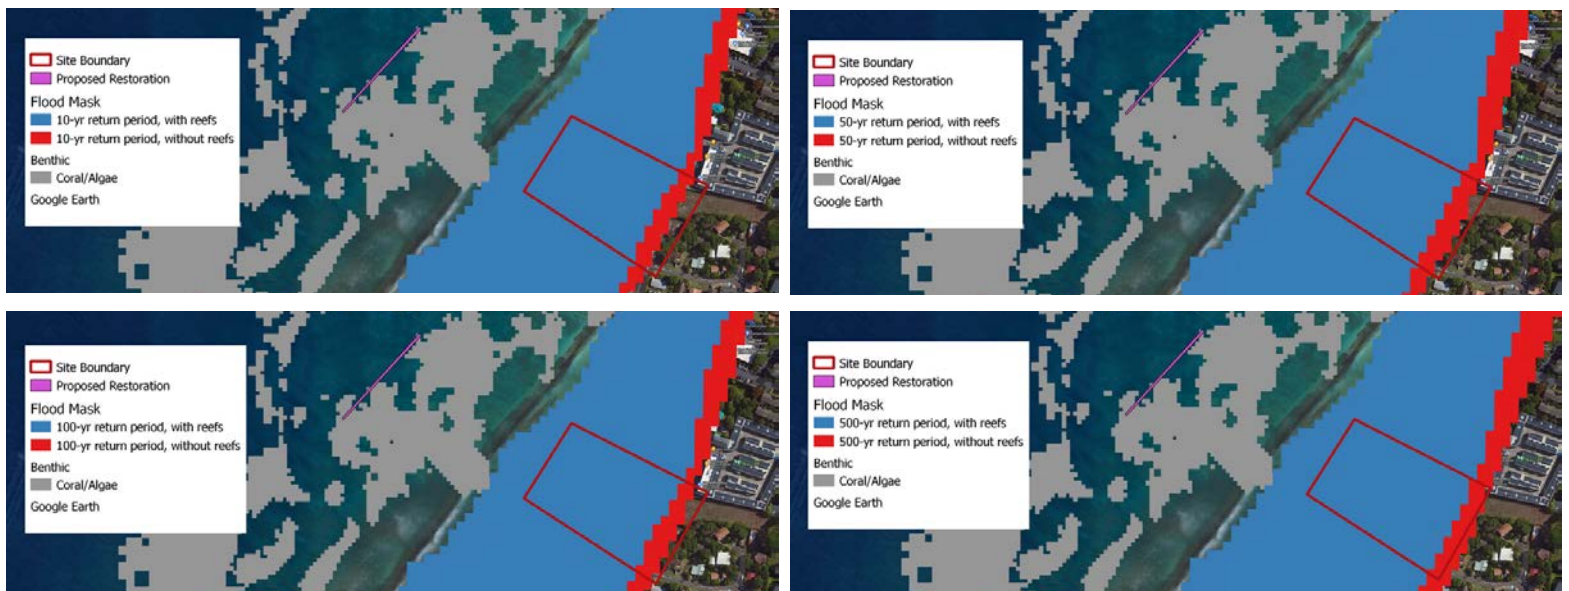
Figure 2L. Maps showing the extent of flooding from multiple storm return periods for the with reefs (blue) and without reefs (red) scenarios at the Maui Sands site.

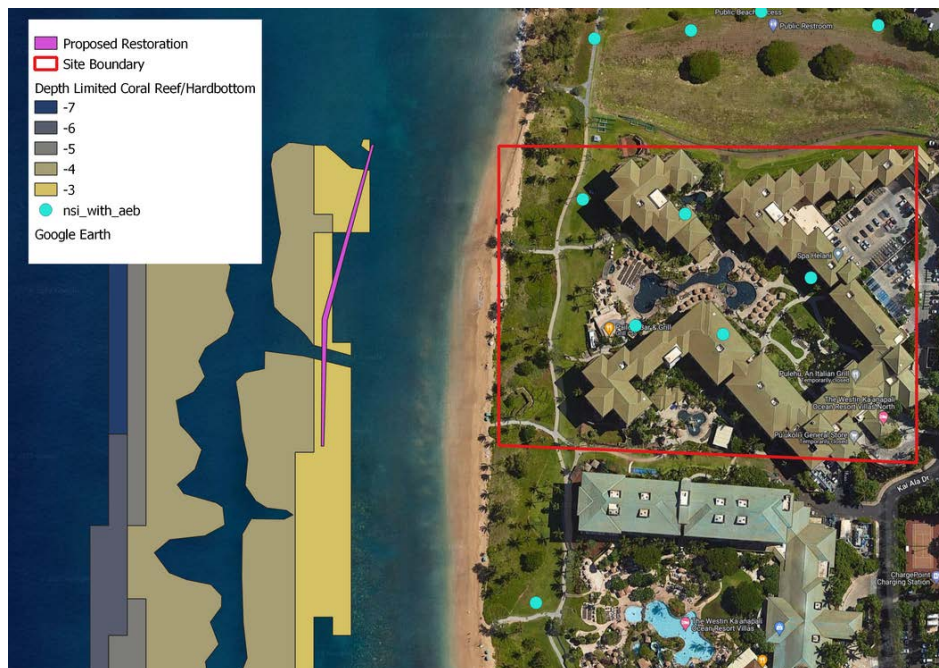
Figure 1M. Map showing the Westin Ka'anapali CR4 project site. The area predicted to receive the most risk reduction benefits from the restoration project is outlined in red. The individual structure annual expected benefit provided by the addition of 1m in reef height is summarized by the teal dots. The isolated area considered feasible for restoration based on depth from 2 m to 7 m and existing coral reef or hardbottom benthos is represented in shades of yellow to blue. The proposed restoration project site is represented in purple.

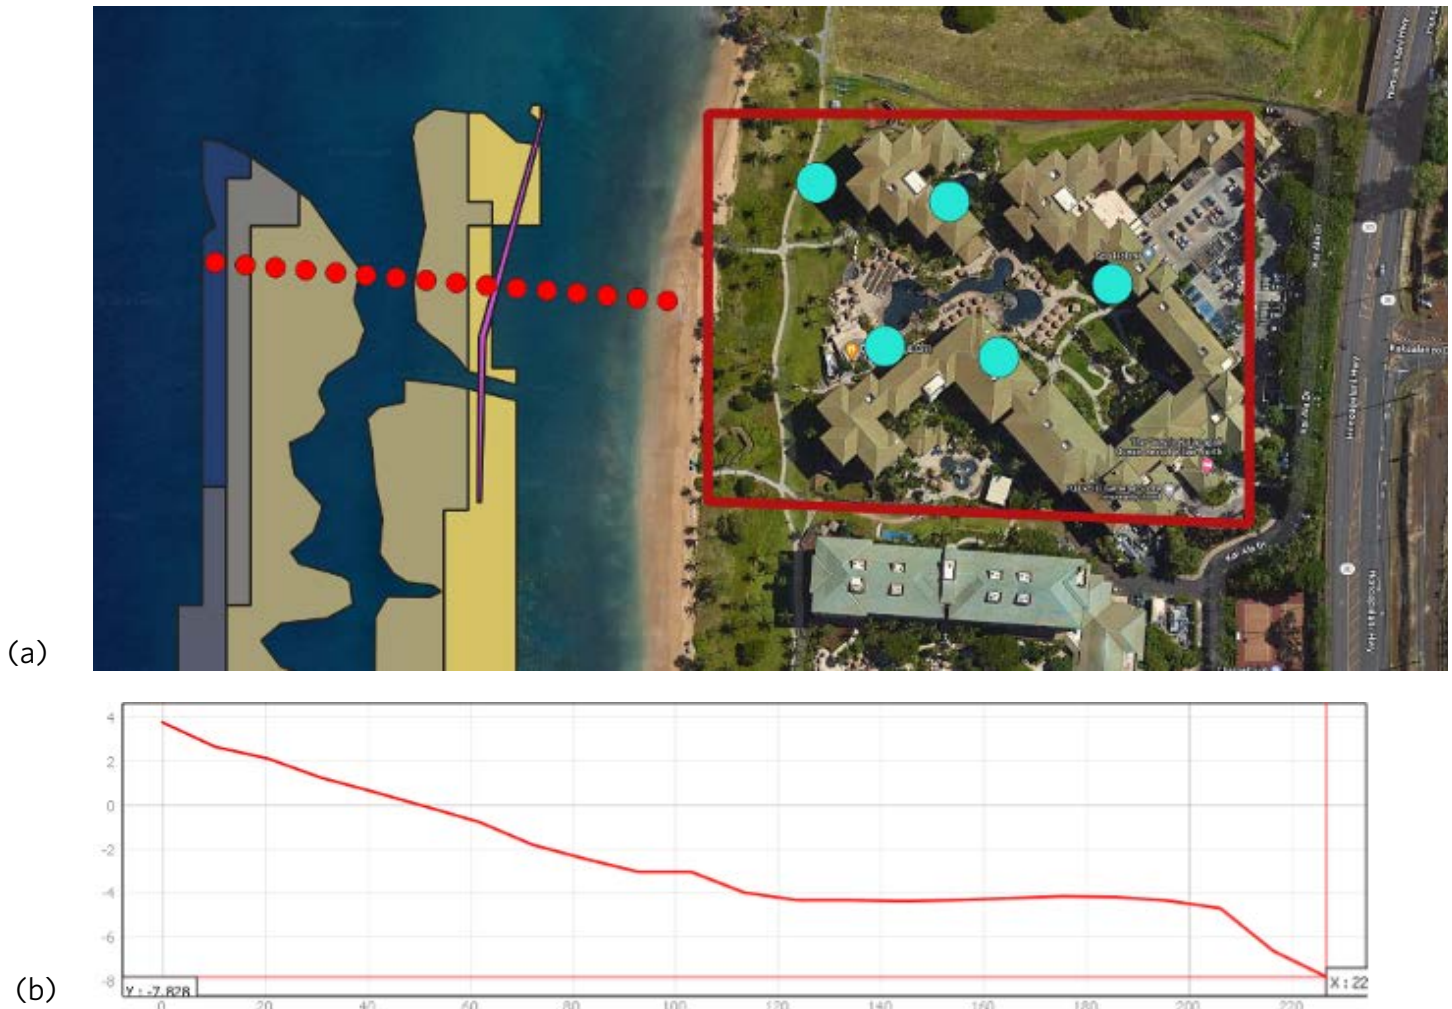
Figure 3M. (a) A screenshot of the approximate cross-shore transect examined using the profile tool in QGIS to evaluate the general reef profile within the 2-7 m depth range. (b) A view of the cross-shore reef profile from the beach out to the end of the 7m depth range. The y-axis is approximate depth in meters. The reef profile between 2-7 m depth starts at the 90 value on the x-axis.

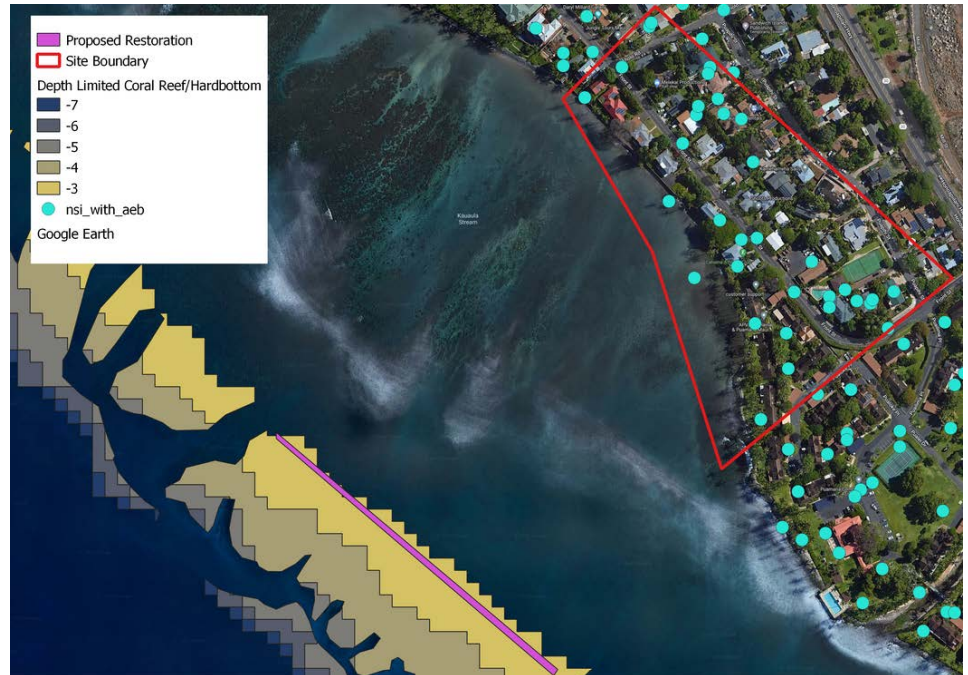
Figure 1N. Map showing the Kauaula Stream CR4 project site. The area predicted to receive the most risk reduction benefits from the restoration project is outlined in red. The individual structure annual expected benefit provided by the addition of 1m in reef height is summarized by the teal dots. The isolated area considered feasible for restoration based on depth from 2 m to 7 m and existing coral reef or hardbottom benthos is represented in shades of yellow to blue. The proposed restoration project site is represented in purple.

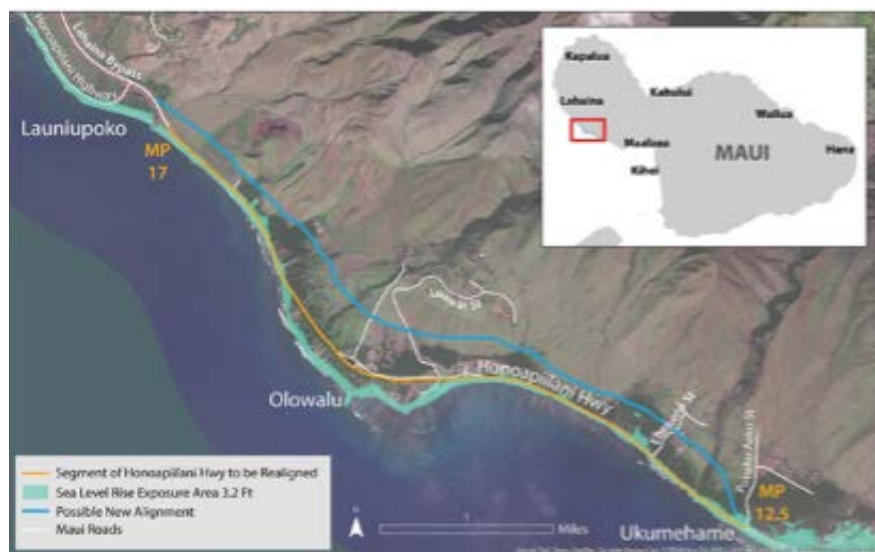
Figure 10. A preliminary figure from HI DOT showing the proposed realignment of the Honoapiʻilani Highway (Route 30).

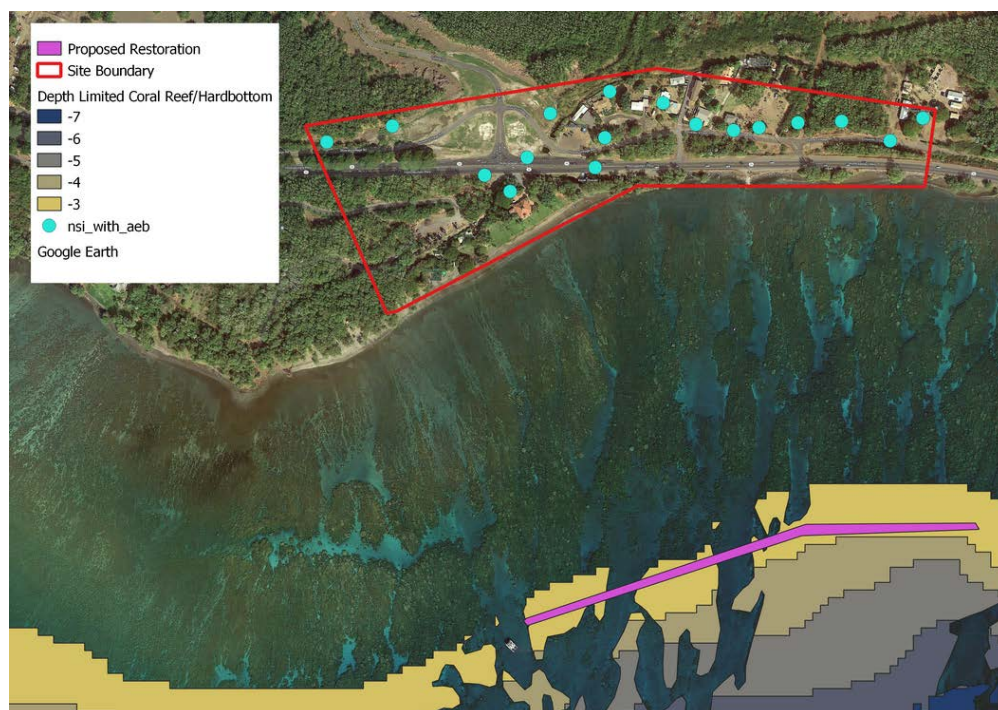
Figure 20. Map showing the Olowalu CR4 project site. The area predicted to receive the most risk reduction benefits from the restoration project is outlined in red. The individual structure annual expected benefit provided by the addition of 1m in reef height is summarized by the teal dots. The isolated area considered feasible for restoration based on depth from 2 m to 7 m and existing coral reef or hardbottom benthos is represented in shades of yellow to blue. The proposed restoration project site is represented in purple.

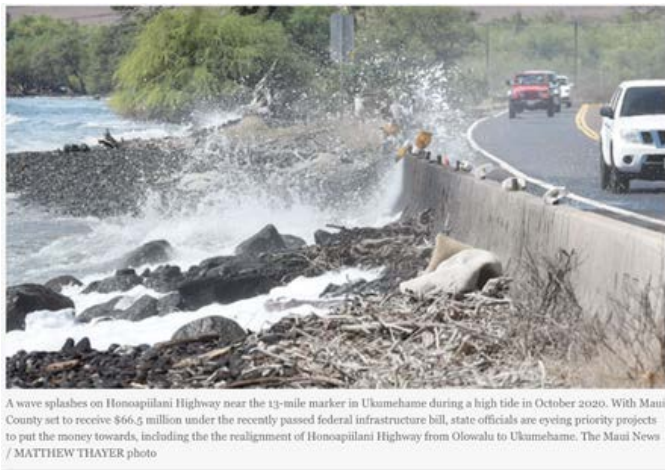
Figure 40. Photo from a The Maui News article showing high wave energy impacting a portion of the Honoapi'ilani Highway at Olowalu.

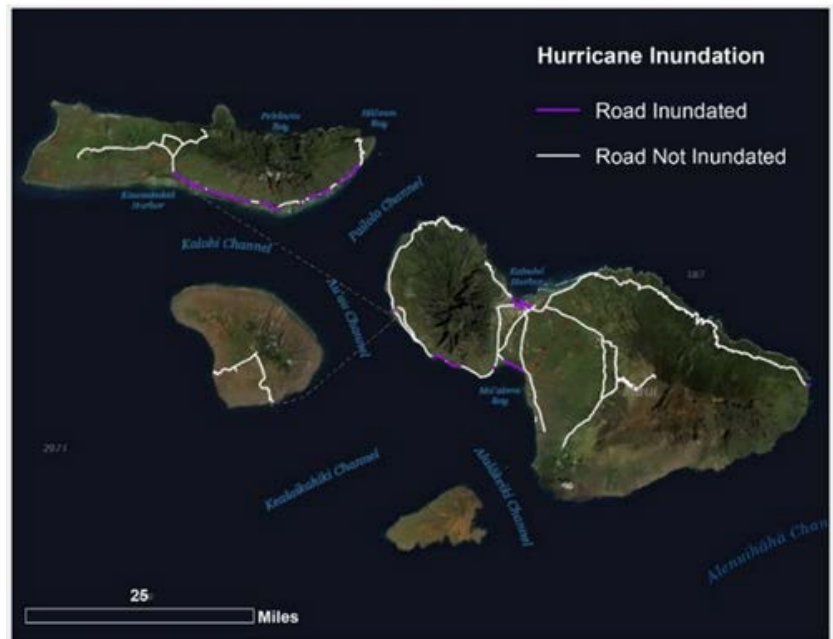
Figure 50. Image from the HI DOT Climate Resilience Action Plan Exposure Assessment showing vulnerable roadways to inundation due to coastal flooding events like hurricanes.

Olowalu is a site where reef restoration could have significant flood risk reduction benefits to this critical roadway and the existing and future Olowalu community. The Olowalu area is a priority site for implementing nature-based solutions because of the Honoapiʻilani Highway (Route 30), which lies adjacent to the Olowalu reef tract and is prone to coastal overwash and inundation (see Fig. 4 & 5). During large wind and swell events, portions of Route 30 are consistently flooded, causing disruptive closures to this critical roadway (see Fig. 5).

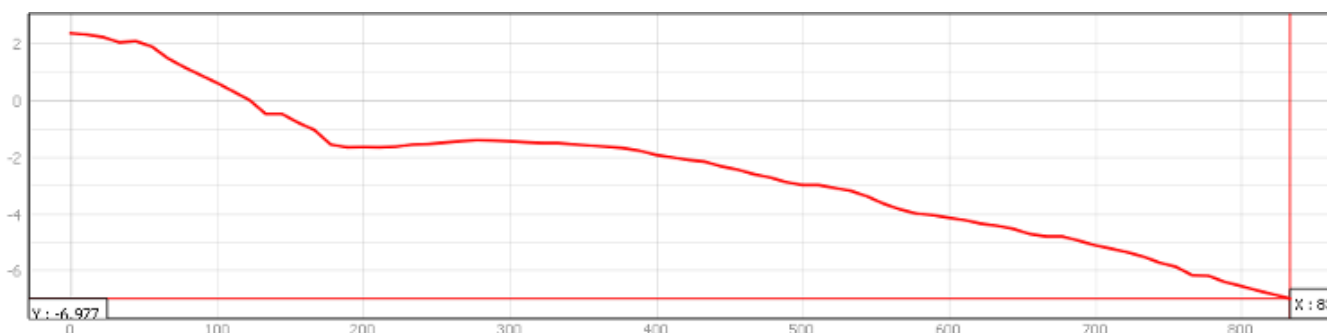
(b)

Reef Profile Assessment: convex or linear
