COASTAL ADAPTATION VISION FOR NAVAL BASE VENTURA COUNTY POINT MUGU

Prepared for
The Nature Conservancy and
Naval Base Ventura County

September 2020

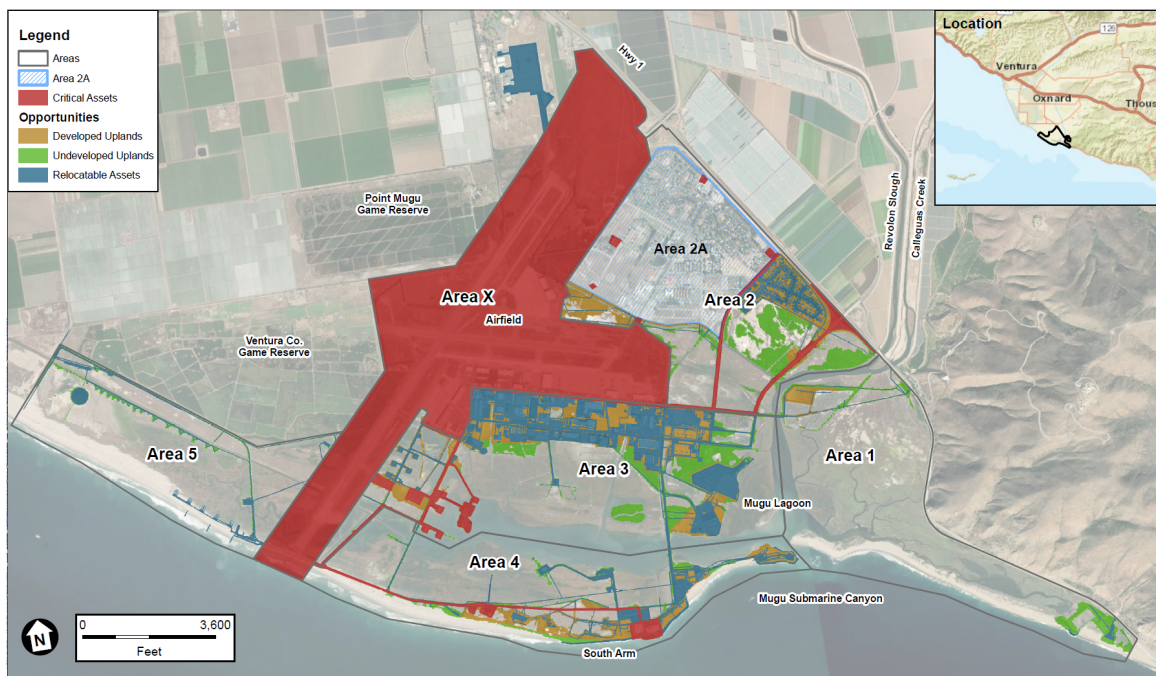
The Adaptation Vision is summarized in Figure ES-1. Critical asset areas (red) are maintained in place, assets (blue) in Areas 3, 4, and 5 are relocated to Area 2A or removed altogether, these and the remaining fill area (brown) are restored along with the restoration and or enhancement of adjacent uplands (green). There are assets in Area 5 and east Area 1 that cannot be moved to Area 2A owing to safety regulations and hence their locations may be optimized after specific study.

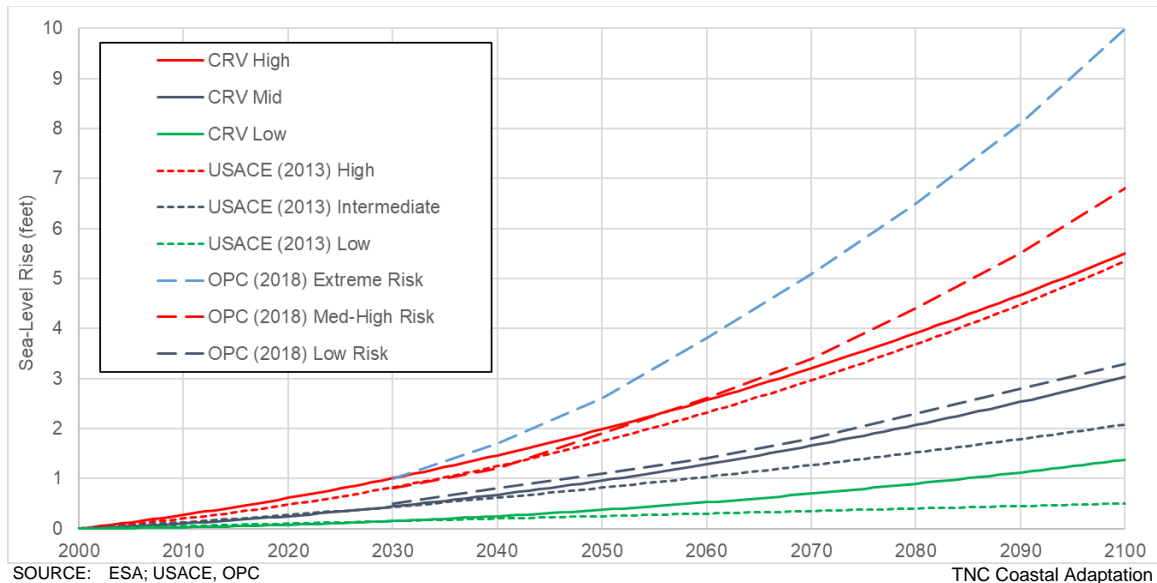
Figure 2
Sea Level Rise Projections from Various Guidance

Since the CRV scenarios for sea-level rise were developed using the best available guidance for California at the time (NRC 2012; OPC 2013), state guidance was updated in 2018 (Griggs et al 2017; CNRA & OPC 2018). As shown in **Figure 2**, the CRV High scenario tracks similarly to the 2018 Medium-High Risk Aversion low emission scenario but diverges from the Medium-High Risk Aversion high emission scenario after 2060, and is 1.3 feet lower than this scenario by 2100. The differences with the H++ scenario are much greater, and the projections diverge sooner.

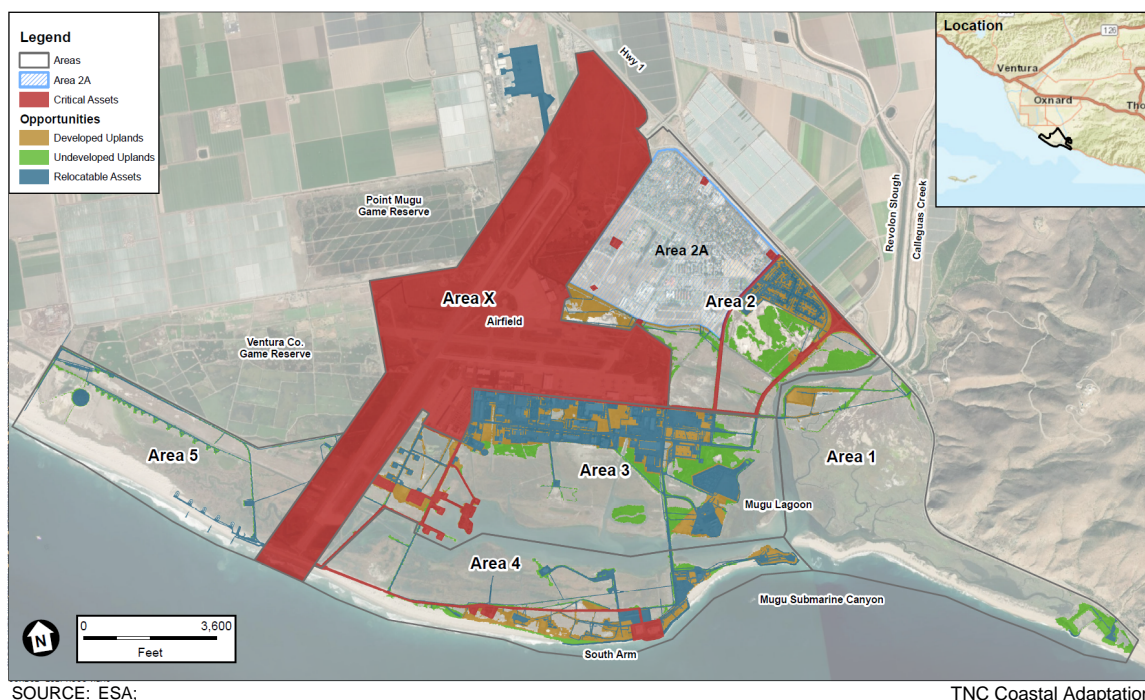
Figure 12
Adaptation Opportunities and Constraints at NBVC Point Mugu

Opportunities and constraints mapping was updated and refined to include access roads and utilities that serve the critical assets outside of Area X and 2A. Figure 12 shows the various constraints and opportunities on the base. Critical assets shown in red include the airfield and supporting infrastructure (Area X) and other facilities in Areas 2, 3, 4, and 5, as well as entrance access to the base. Area 2A (light blue hatch) could receive the relocated/realigned assets from elsewhere on the base and be protected over time. Opportunities are represented by assets throughout the base that are removable/relocatable and associated developed uplands and undeveloped uplands. Undeveloped uplands (green) include filled areas within the lagoon that could be restored to wetlands or used as other natural infrastructure features. Note there are assets in Area 5 and east Area 1 that cannot be moved to Area 2A owing to safety issues and hence their locations may be optimized after specific study.

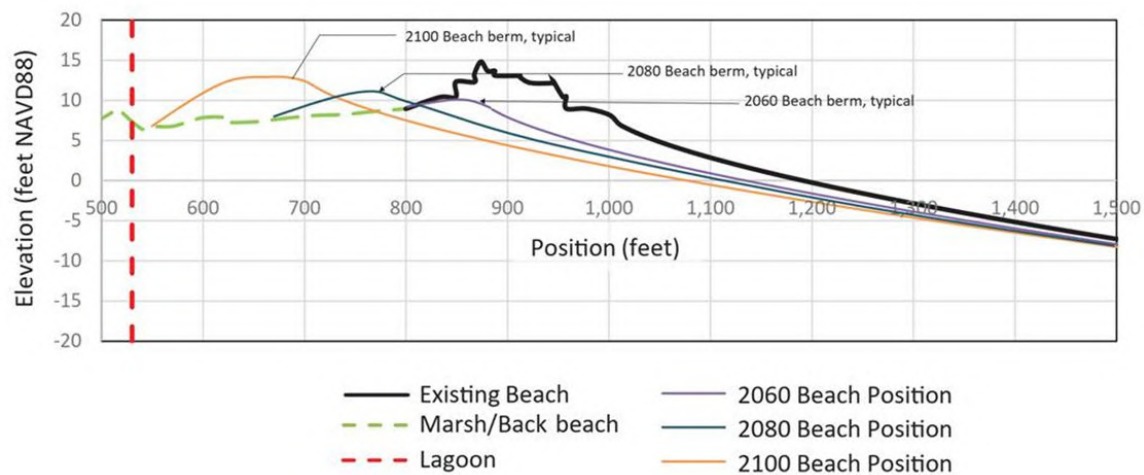
Figure 14
Conceptual Schematic of Future Shore Migration at Ormond Beach,
vicinity of Arnold Road, upcoast from NBVC Point Mugu

The Adaptation Vision calls for built assets to be removed from the strand, thereby allowing the shore to migrate landward but maintain its high beach and dunes which provide protective services to the Mugu Lagoon and built base assets in Areas X and 2A. Figure 14 provides a projection of shore migration just north of NBVC Point Mugu at southern Ormond Beach, near Arnold Road (ESA 2019). This figure shows the transgression (landward and upward migration with sea-level rise) induced by waves building the beach and wind building the dunes.

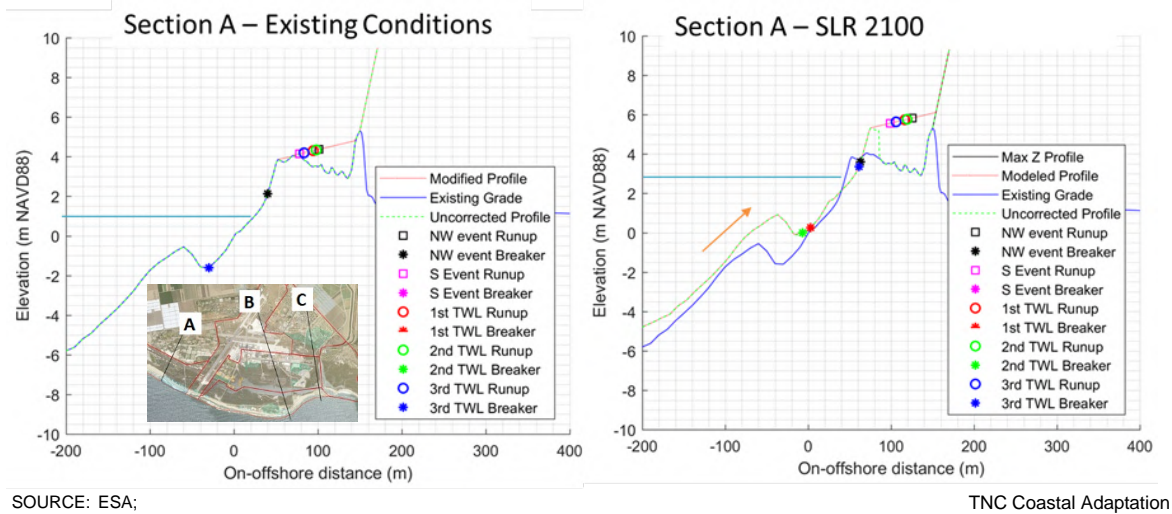
Figure 16
Wave run-up at Section A (Area 5) for existing (left) and future (right) conditions

ESA analyzed wave run-up at NBVC, building upon prior work (ESA PWA 2014; ESA 2019). As shown in Figure 16 and Figure 17. In each figure, the horizontal light blue line represents MHW elevation. The beach profile is shown as black and dashed green while the red line shows a monotonic slope projection defined for run-up computations. Five wave events were simulated as shown in the legend, squares and circles represent the landward limit of run-up while the corresponding wave breaking point is shown on the profile with an asterisk. Descriptions for each figure are provided in the next paragraph.

Figure 16 shows the wave run-up computed for Area 5 (labeled Section A), presuming the shore can migrate, for existing and future sea level at 2100. The wave run-up elevation increases about the same as the amount of sea-level rise while the entire shore profile migrates landward and up. Note that the model did not include dune building by wind (which is probable), and hence the backshore beyond the beach was not modified for future conditions. Figure 17 shows the wave run-up computed for Area 3 where massive shore protection has been installed. Note that the predicted future run-up increases more than 4 times the amount of sea-level rise, indicating a non-linear increase in wave overtopping and hydraulic loadings on armoring structures. The run-up analysis was accomplished using methods consistent with Guidelines for Pacific Coast Flood Studies (FEMA 2005) and the Coastal Engineering Manual (USACE 2003).
